PROPERTY INSPECTION REPORT

Prepared For: _____
Jane Doe
(Name of Client)

Concerning: _____
County Road 123
(Address or Other Identification of Inspected Property)

By: _____
Dale Cumberland License # 4540 November 10, 2021
(Name and License Number of Inspector) (Date)

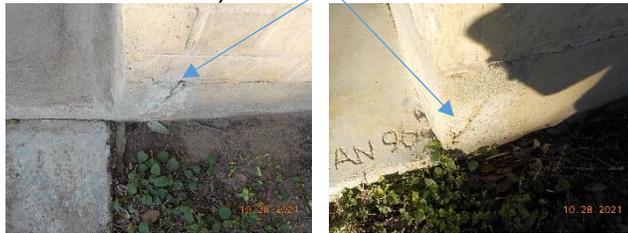
Deficiency – The corners of the foundation have cracked / broken (probable result of lateral expansion of masonry wall friction on foundation, pushing the corner outward).

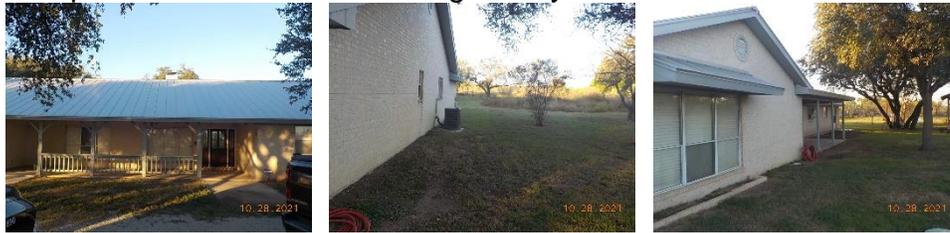
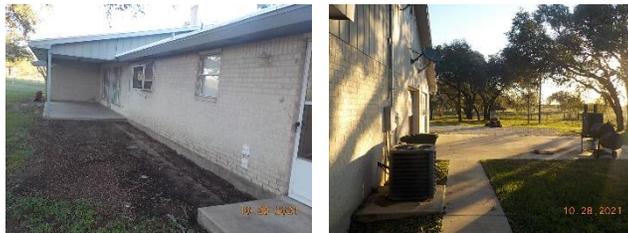
Deficiency – The yard areas adjacent to the foundation do not appear to have adequate fall to allow for drainage away from the foundation.

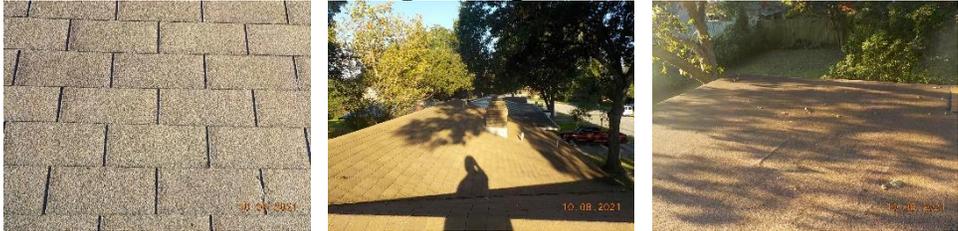
Comment – The roof covering is in aged overall condition.

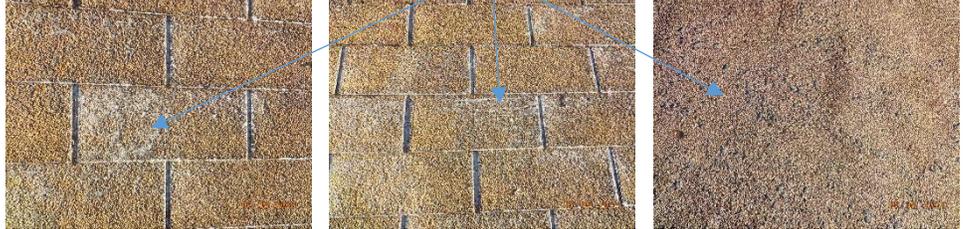
Deficiency – There are indications of hail damage to the roof covering (impact marks). Recommend insurance adjuster fully evaluate roof covering for hail damage / adjustment.

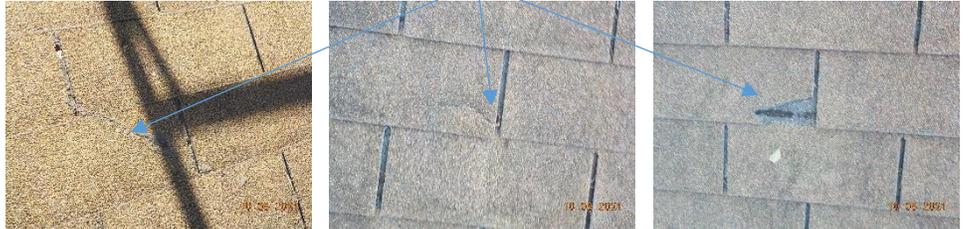
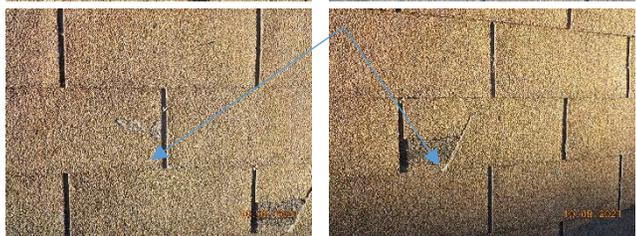
Deficiency – There are multiple damaged shingles (possible previous tree branch contact).

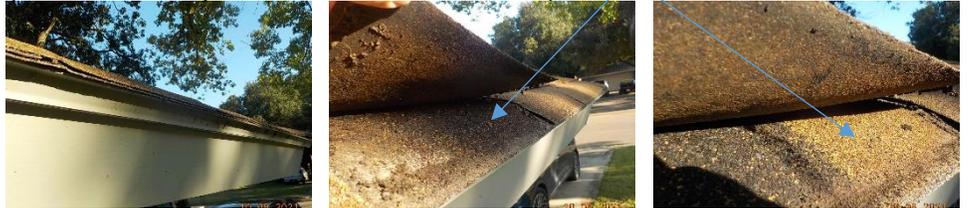
Deficiency – The bottom row of shingles are not adequately sealed / secured (no starter strip with adhesive installed).

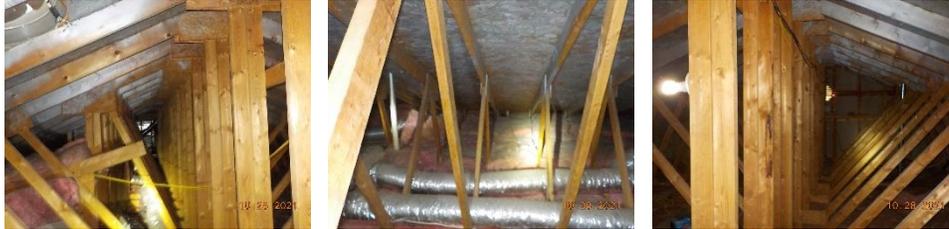
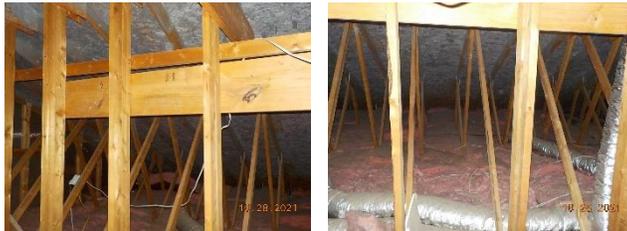
Comments – The roof is constructed of 2 x 6 trusses with wood decking. There are 5 - 6 inches of insulation present (approximate R 19).

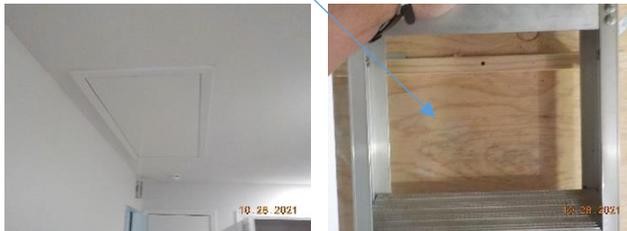
Deficiency – There is inadequate insulation in the living area pull down attic access ladder.

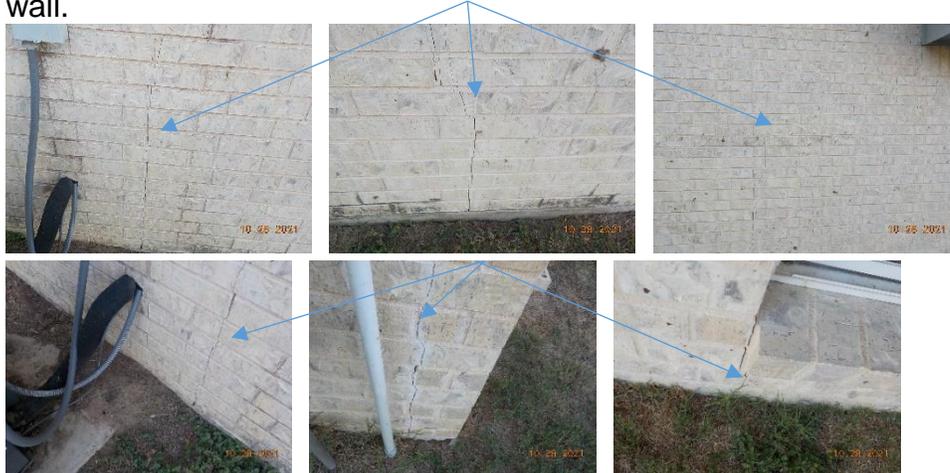
Deficiency – There are cracks in the exterior masonry wall in the right exterior wall.

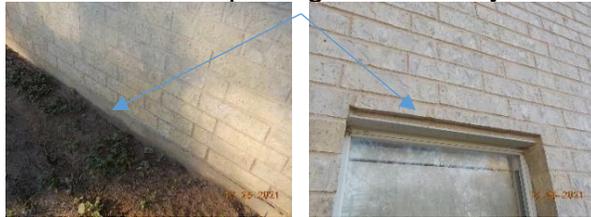
Deficiency – Weep holes are not installed in the lower wall areas and above the window / door openings in masonry wall areas.

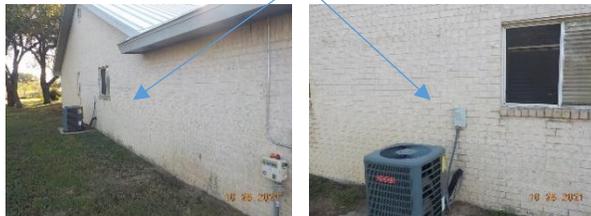
Deficiency – There are inadequate / no expansion joints in the exterior brick wall areas.

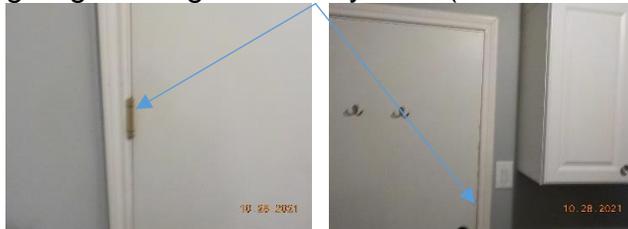
Deficiency – The auto-close spring loaded hinges are not fully operational in the garage / living room entry door (door does not fully automatically close).

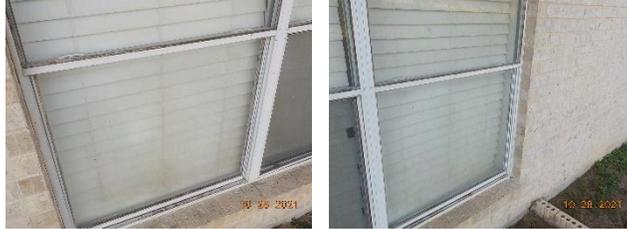
Deficiency – Multiple window screens are not installed (approximate 12).

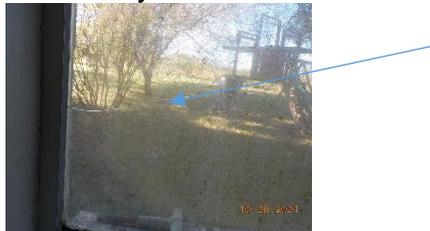
Deficiency – There is a cracked window pane in the master bedroom area.

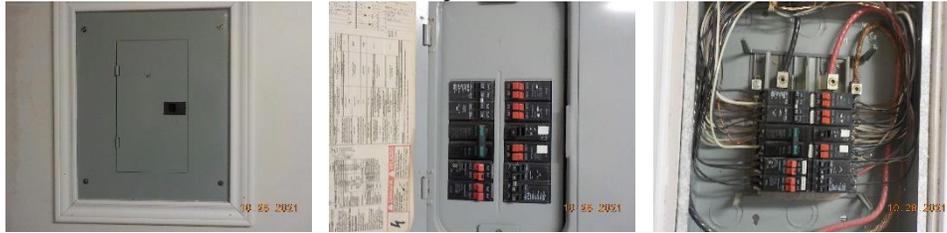
Interior Breaker Panel – Utility Room:

Comment – The branch circuits are not ARC fault protected. ARC fault breakers provide additional protection for bedroom and living area receptacles and lighting.

NEC 210.12 requires that for dwelling units, all 120-volt, single-phase, 15- and 20-ampere branch circuits supplying outlets or devices installed in dwelling unit kitchens, family rooms, dining rooms, living rooms, parlors, libraries, dens, bedrooms, sunrooms, recreation rooms, closets, hallways, laundry areas, or similar rooms or areas shall be protected by AFCIs.

Deficiency – The panel is serviced by a three wire connection (newer services require four wire connection from exterior disconnect panel to interior breaker panel). There is no isolated bus bar for the ground cable connections.

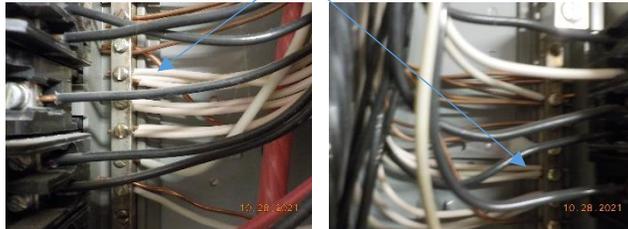
Deficiency – There is double lugging on one or more neutral cable connections to the bus bar.

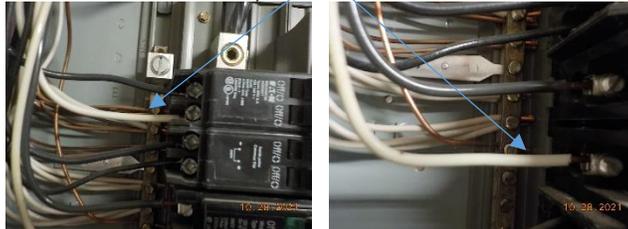
Deficiency – There are one or more white cables landing on a breaker (should be color identified).

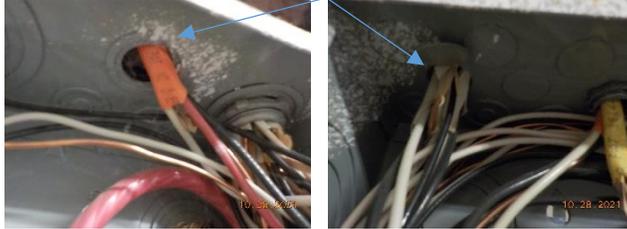
Deficiency – There is inadequate cable clamp protection (to protect electric cables from sharp edges where entering panel) where one or more of the cables exits the breaker panel.

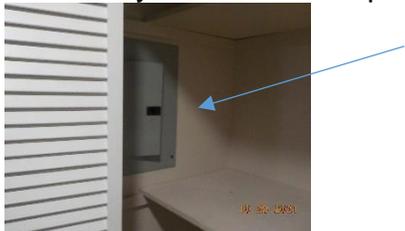
Deficiency – The breaker panel is located in a prohibited area (clothes closet).

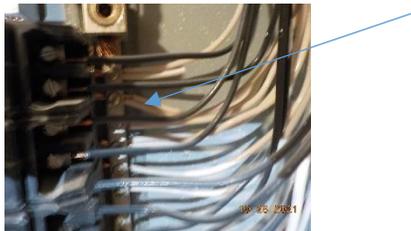
Deficiency – There is double lugging on one or more neutral cable connections to the bus bar.

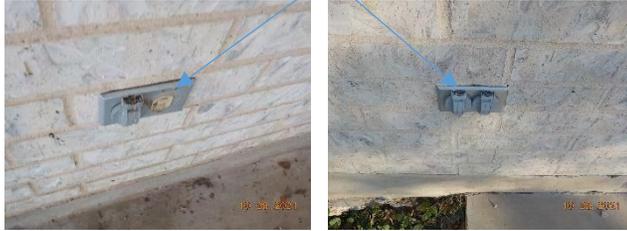
Deficiency – There is inadequate weather protection on one or more of the exterior receptacles.

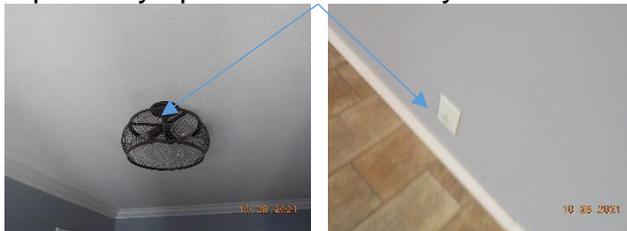
Deficiency – The power to the front entry hall light fixtures / receptacles went out when tested. The power turned on when the entry hall switch was repeatedly operated. There may be an electric defect in the circuit.

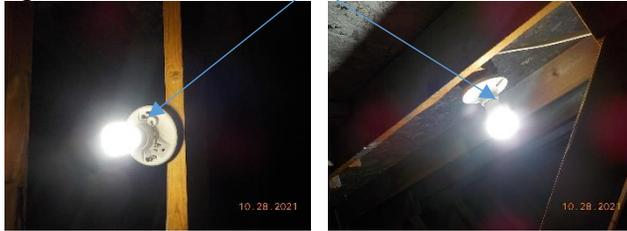
Deficiency – There is no physical protection from breakage on the attic located light fixture bulb.

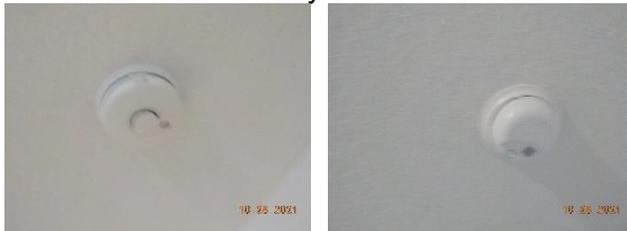
Deficiency – Smoke detectors are not installed in each bedroom entry / outside of each bedroom entry area.

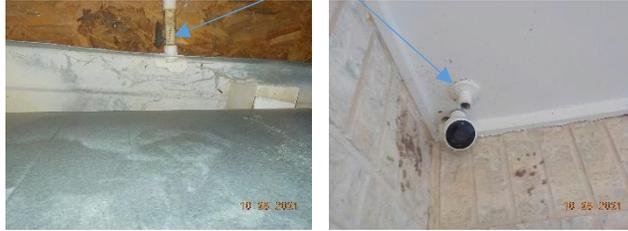
Comment – The drain line for the overflow pan terminates in the front covered porch area.

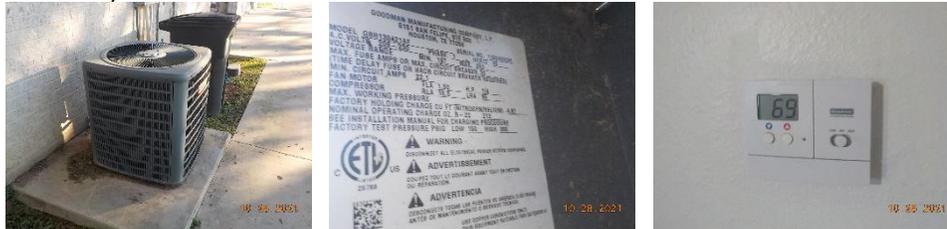
Comment – The differential temperature between the return air and the supply air should be between 15 and 22 degrees. The differential in this unit is adequate, indicating that the unit is operating normally (Goodman, 2011, 3 ½ ton unit).

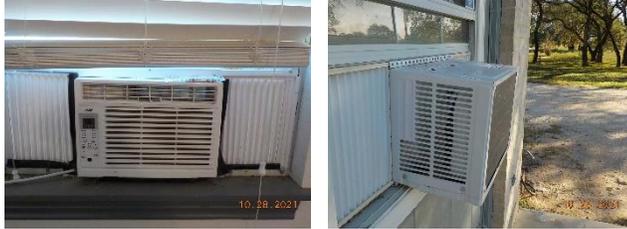
Front Left Room:

Comment – There were no observable significant defects in the window unit. The unit supplied cooled air at 38 degrees when operated.

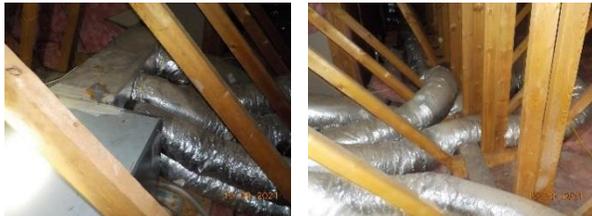
Comment – The ducting does not meet 2015 Energy Efficiency guidelines. There is no fresh air intake in the return air with a timer for air intake.

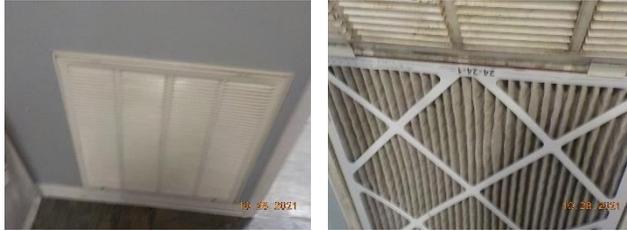
Comment – The return air register is located in the left lower wall area.

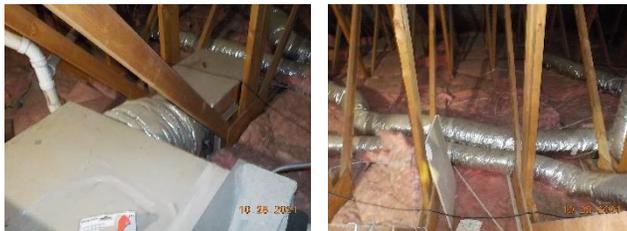
Comment – The ducting does not meet 2015 Energy Efficiency guidelines. There is no fresh air intake in the return air with a timer for air intake.

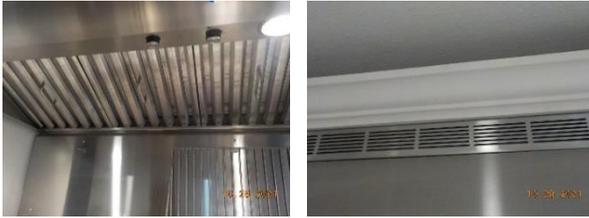
Comment – There were no observable defects in the range hood and vent. The unit recirculates filtered air.

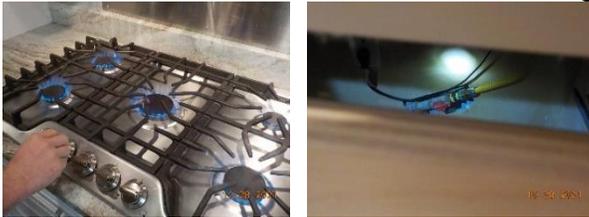
Comment – There were no observable significant defects in the gas range.

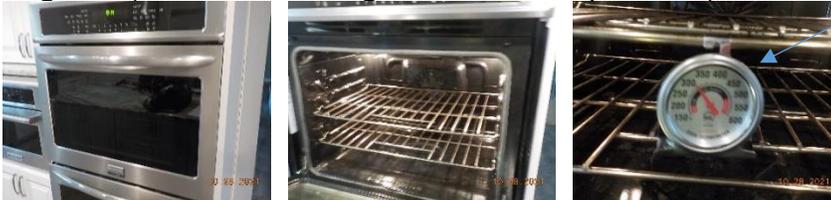
Deficiency – The upper oven, when set at 350 degrees, operated at 300 degrees (not within 25 degrees of set temperature).

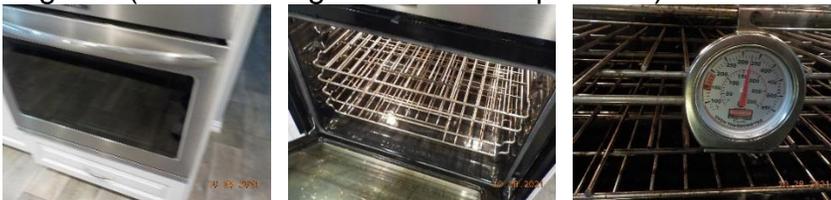
Comment – The lower oven, when set at 350 degrees, operated at 330 degrees (within 25 degrees of set temperature).

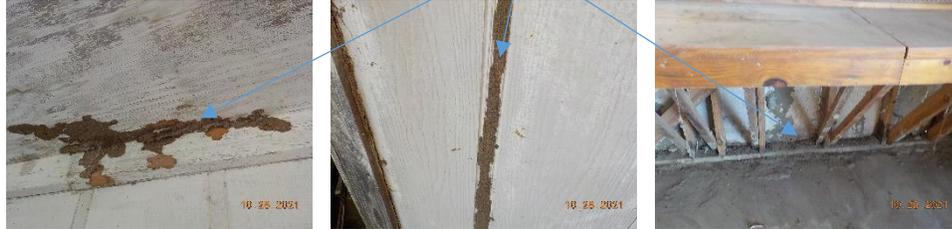
Walls:

Deficiency – There is damage from wood destroying insect activity to the wall areas.

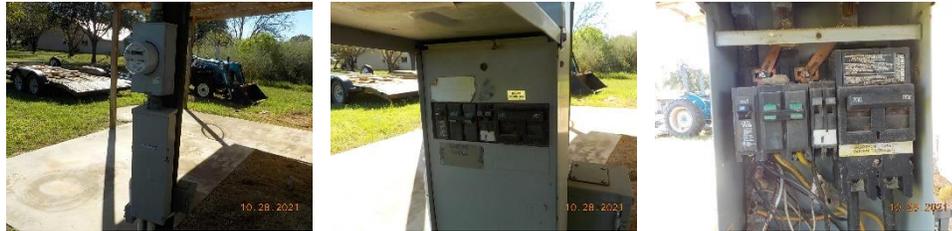
Exterior:

Deficiency –The breakers are not labeled as to use.

Deficiency –There is double lugging (two wires on one breaker) in the panel.

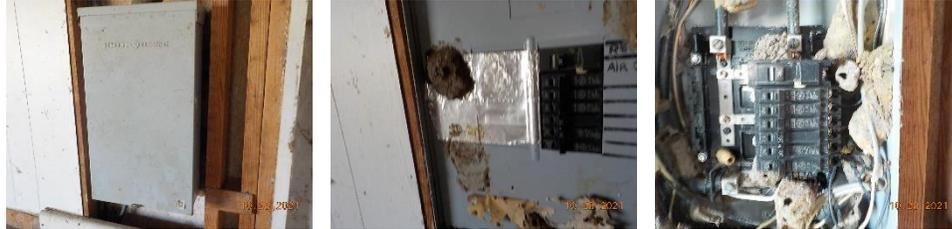
Interior:

Deficiency –The panel cover hinge screw is not installed.
